The Road Inventory of San Joaquin River National Wildlife Refuge Los Banos, CA

Prepared By:
Federal Highway Administration
Central Federal Lands Highway Division
June 2012

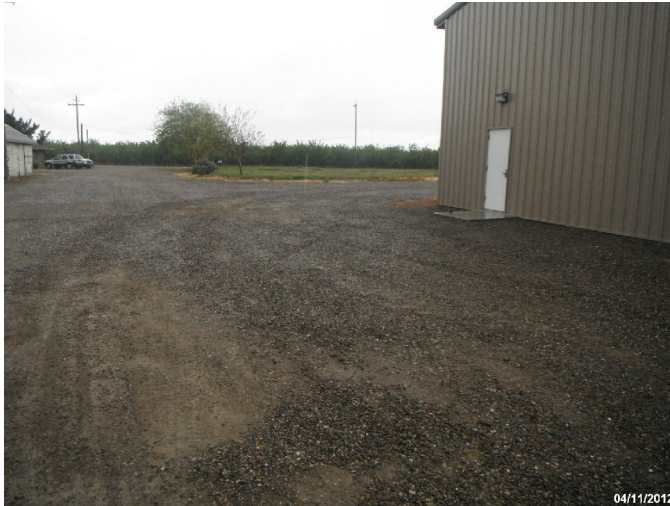
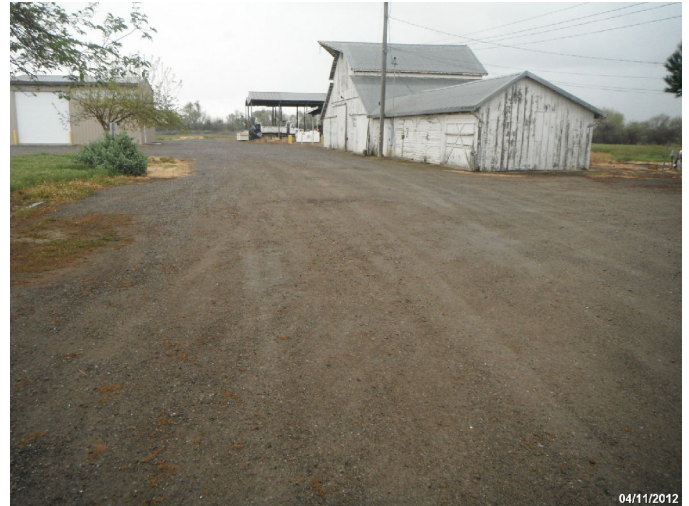
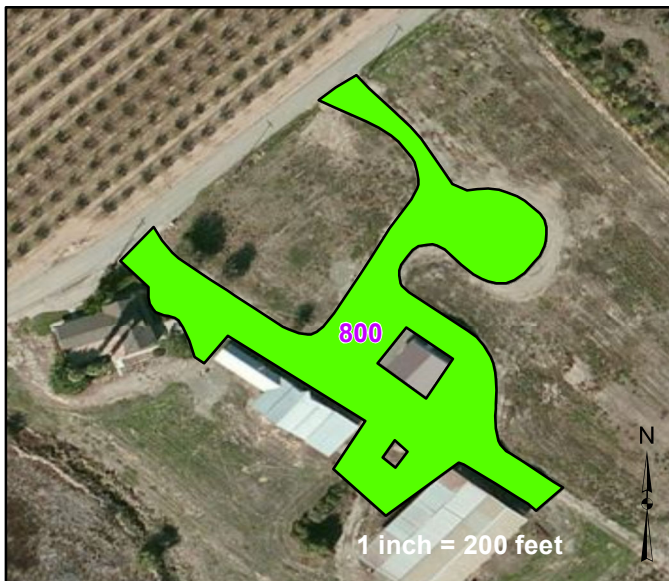
Route Number:800

Asset Number	Area (Sq Ft)	Condition	Surface Type	Cost to Improve	Inspection Date	Current Replacement Value
-	46960	Good	Gravel	\$7,800	04-11-2012	\$256,000

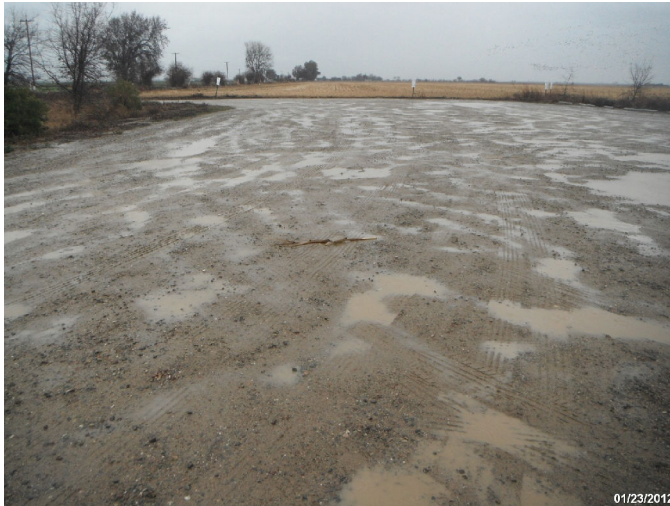
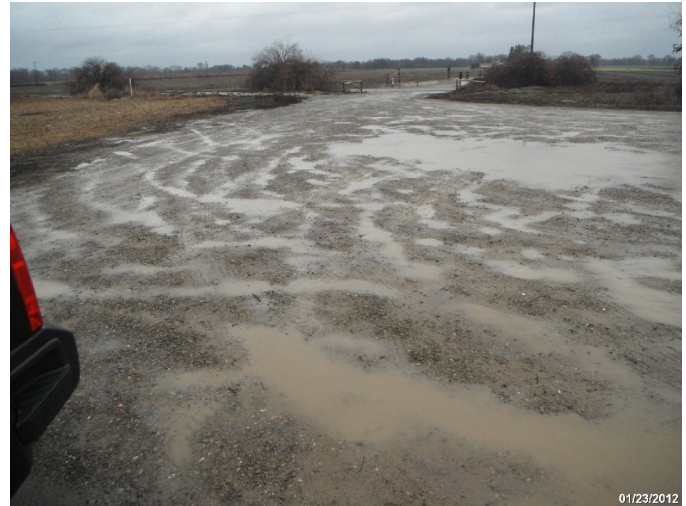
Route Number:900
Beckwith Overlook Parking
From Beckwith Road

Asset Number	Area (Sq Ft)	Condition	Surface Type	Cost to Improve	Inspection Date	Current Replacement Value
10048300	21629	Fair	Gravel	\$6,900	01-23-2012	\$129,800

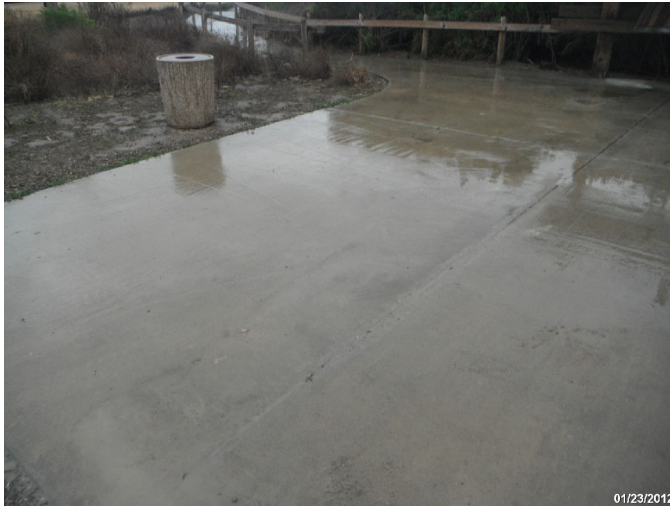
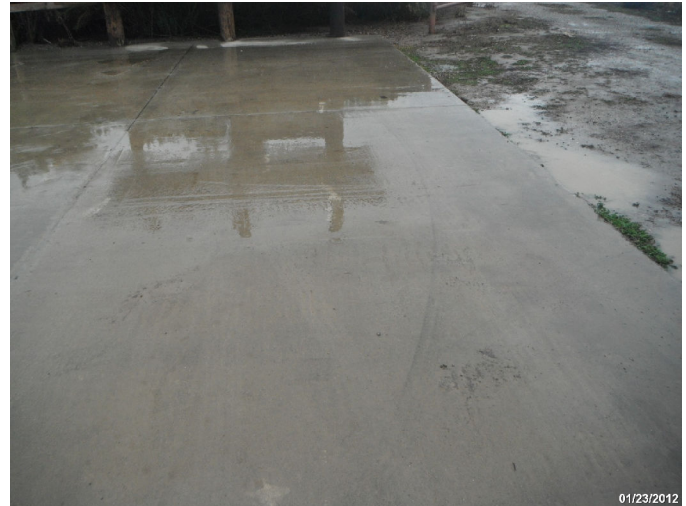
Route Number:901

Asset Number	Area (Sq Ft)	Condition	Surface Type	Cost to Improve	Inspection Date	Current Replacement Value
-	664	Good	Concrete	\$100	01-23-2012	\$8,900

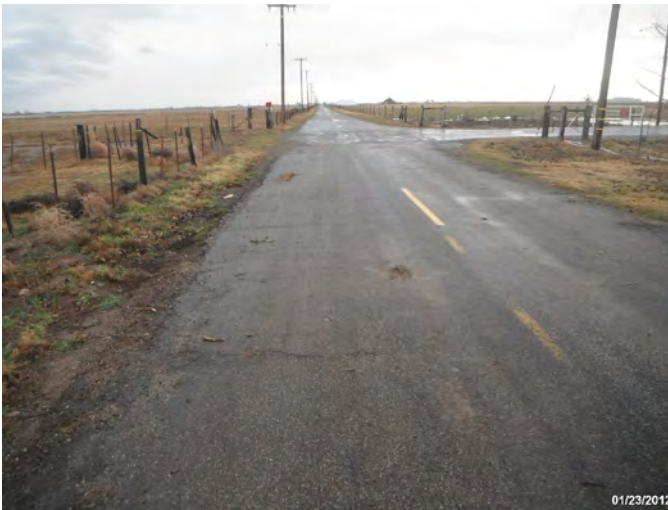
Photo: SAJO_C4_0352 Route: 100-001-0.0
Begin Section Property boundary is at midline and maintenance is done by neighbor and county

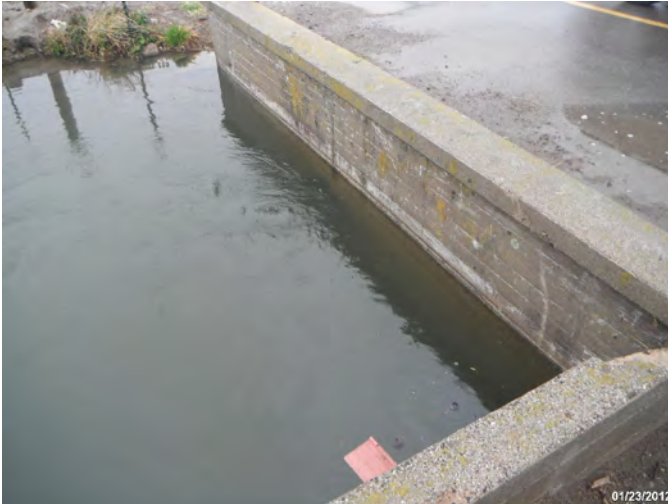
Photo: SAJO_C4_0354 Route: 100-001-0.45
Concrete Culvert 30ft long 60in dia. 1ft deep
Asset# 10048357

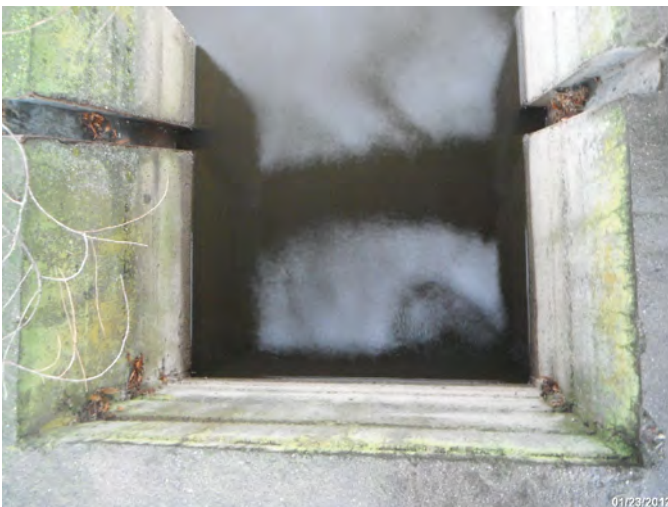
Photo: SAJO_C4_0356 Route: 100-002-0.73 Concrete WCS
Flashboard Riser 100ft long 24in dia. 4ft deep
Asset# NA

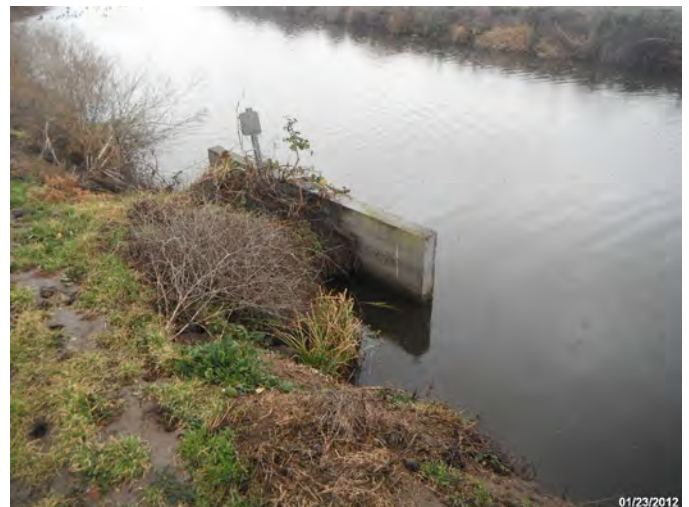
Photo: SAJO_C4_0357 Route: 100-002-0.73 Concrete WCS
Flashboard Riser 100ft long 24in dia. 4ft deep
Asset# NA

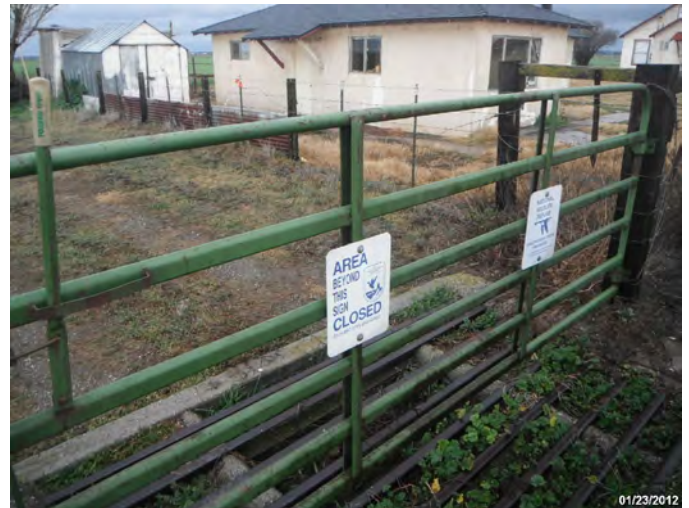
Photo: SAJO_C4_0350 Route: 400-001-0.0
Metal Open Rail Gate
Asset# NA

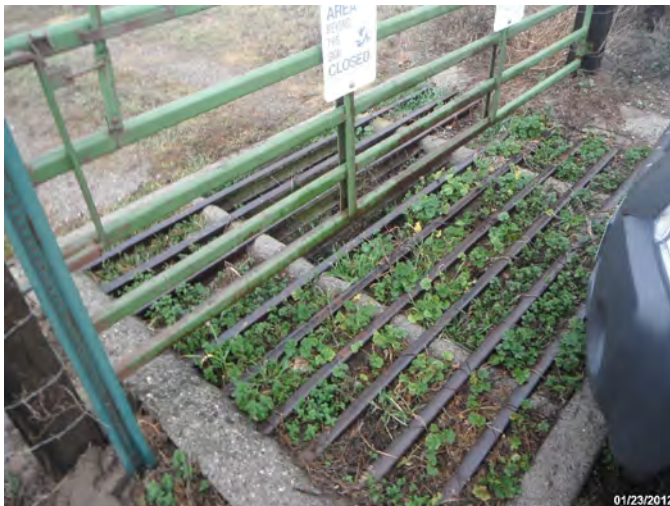
Photo: SAJO_C4_0351 Route: 400-001-0.0
Metal Cattle Guard
Asset# NA

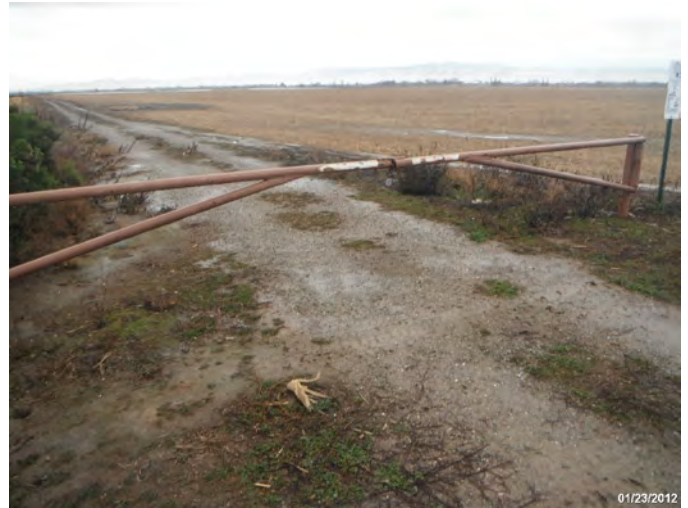
Photo: SAJO_C4_0365 Route: 401-001-0.0
Metal Open Rail Gate
Asset# 10048353

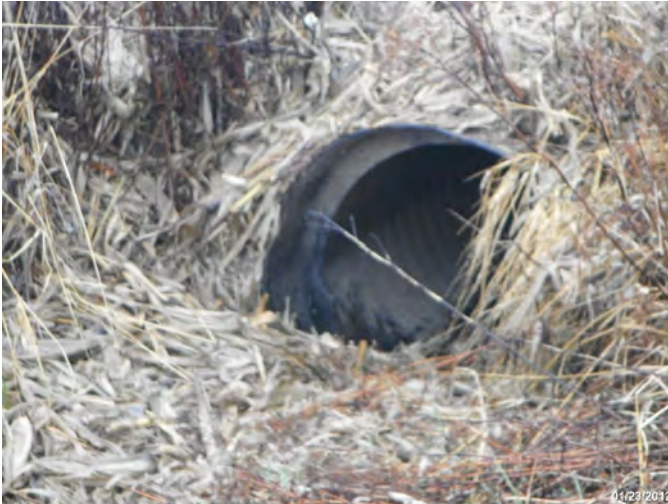
Photo: SAJO_C4_0367 Route: 401-001-0.31
Plastic Culvert 25ft long 24in dia. 2ft deep
Asset# NA

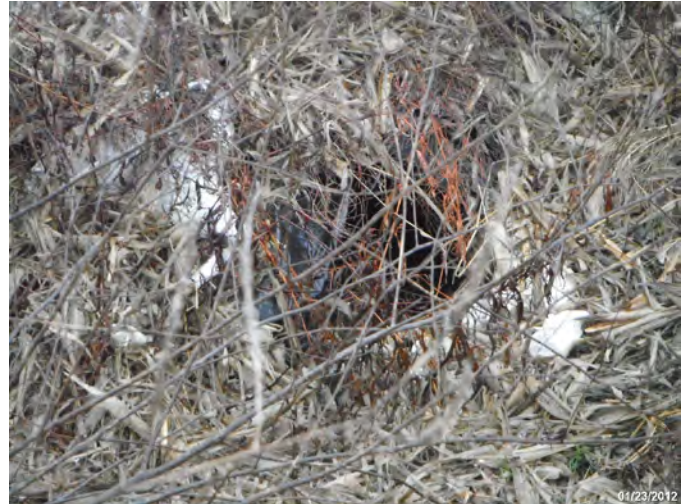
Photo: SAJO_C4_0368 Route: 401-001-0.31
Plastic Culvert 25ft long 24in dia. 2ft deep
Asset# NA

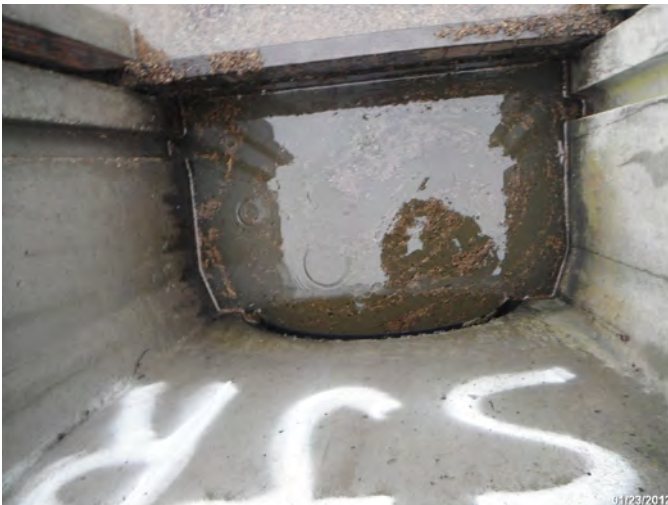
Photo: SAJO_C4_0370 Route: 401-001-0.6
Plastic WCS Flashboard Riser 25ft long 24in dia. 1ft deep
Asset# NA

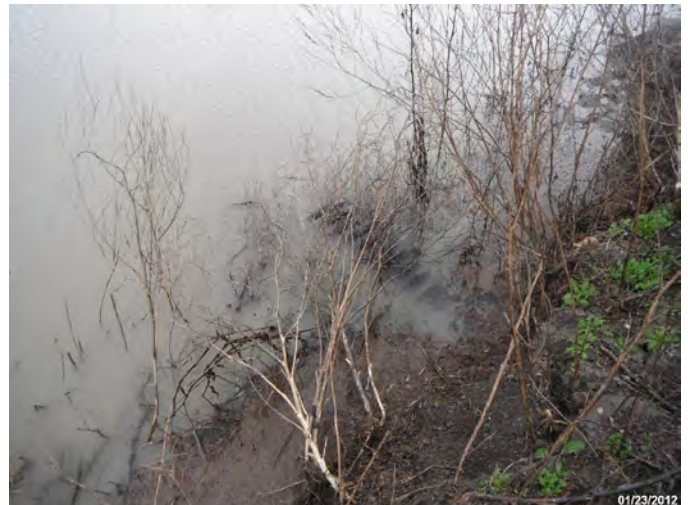
Photo: SAJO_C4_0371 Route: 401-001-0.6
Plastic WCS Flashboard Riser 25ft long 24in dia. 1ft deep
Asset# NA 8-003

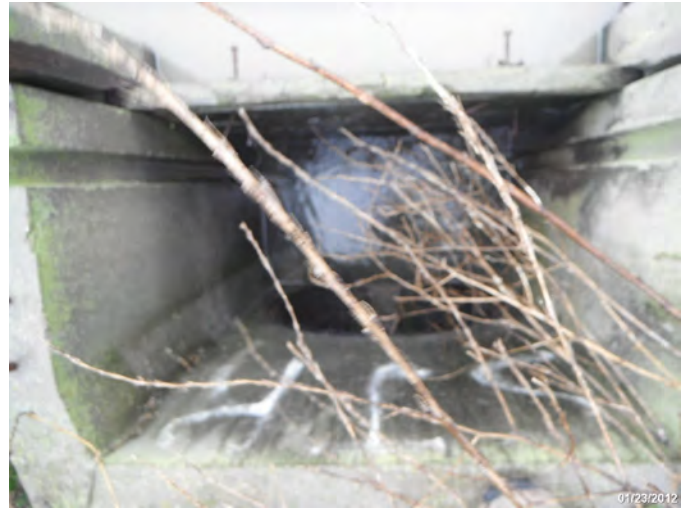
Photo: SAJO_C4_0373 Route: 402-001-0.11
Plastic WCS Flashboard Riser 25ft long 24in dia. 4ft deep
Asset# NA

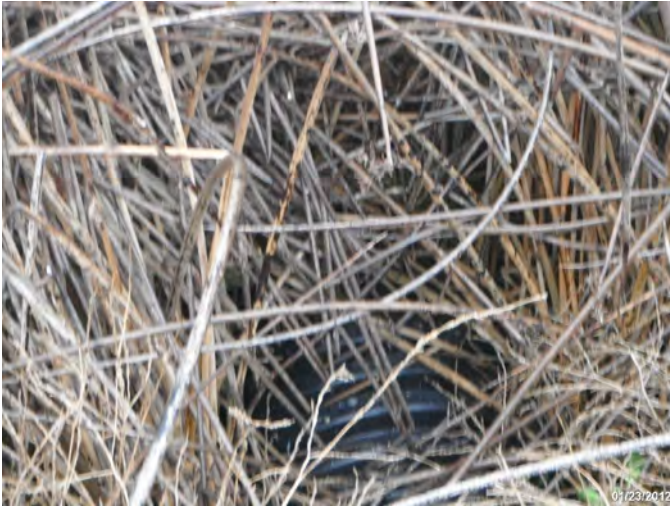
Photo: SAJO_C4_0374 Route: 402-001-0.11
Plastic WCS Flashboard Riser 25ft long 24in dia. 4ft deep
Asset# NA

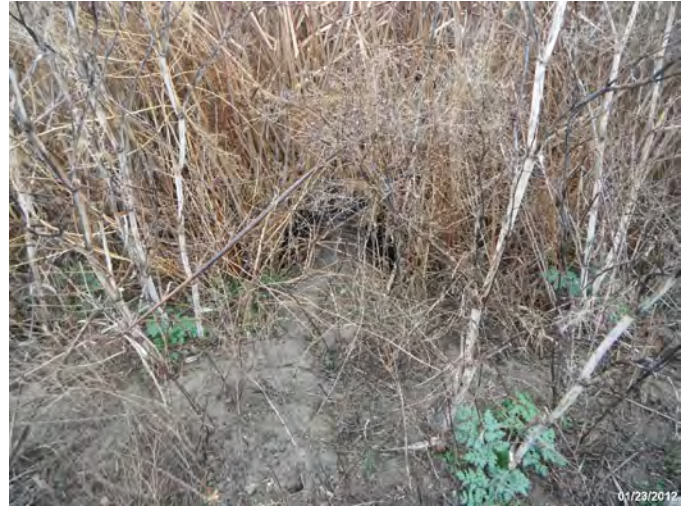
Photo: SAJO_C4_0375 Route: 402-001-0.55
Plastic WCS Flashboard Riser 25ft long 24in dia. 3ft deep
Asset# NA

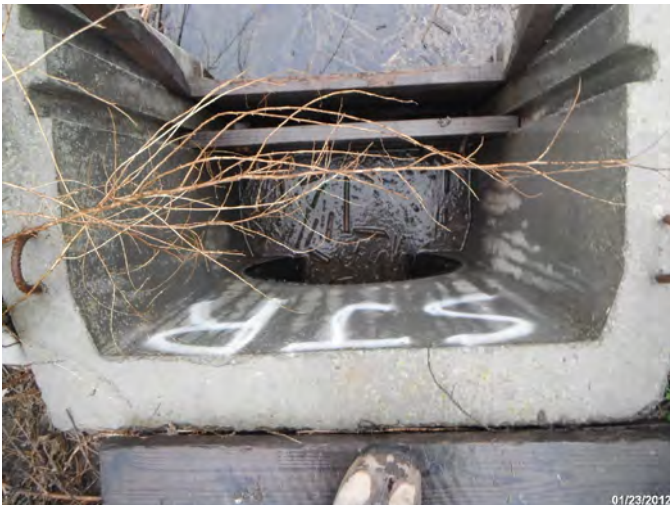
Photo: SAJO_C4_0376 Route: 402-001-0.55
Plastic WCS Flashboard Riser 25ft long 24in dia. 3ft deep
Asset# NA

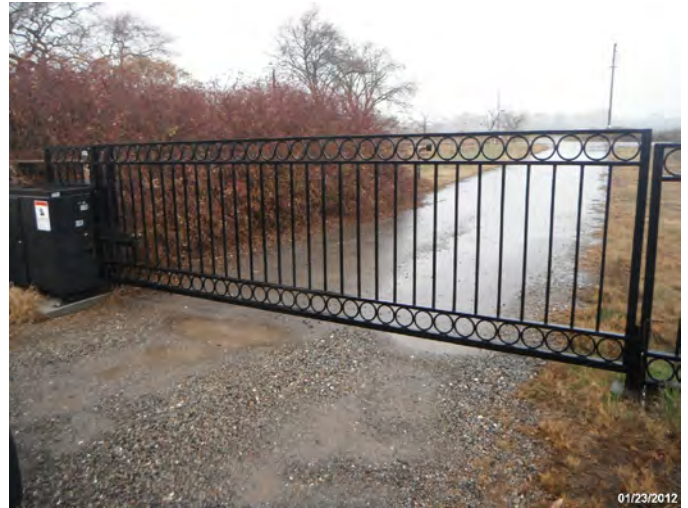
Photo: SAJO_C4_0378 Route: 403-001-0.0
Metal Open Rail Gate Custom gate
Asset# 10048353

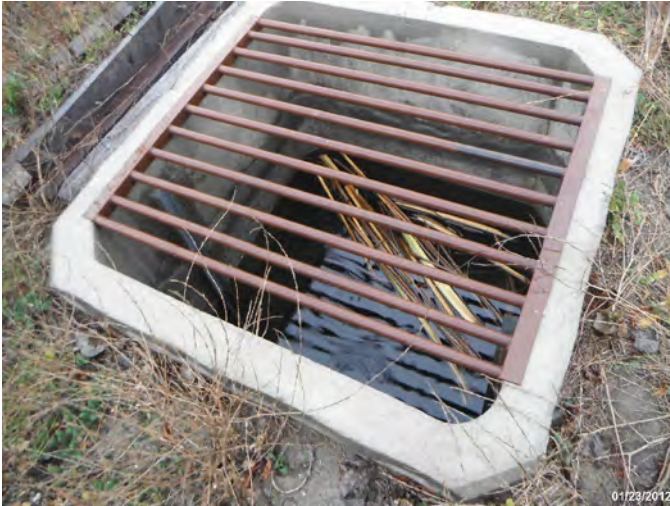
Photo: SAJO_C4_0379 Route: 403-001-0.74
Plastic WCS Drop Pipe 60ft long 24in dia. 3ft deep
Asset# NA

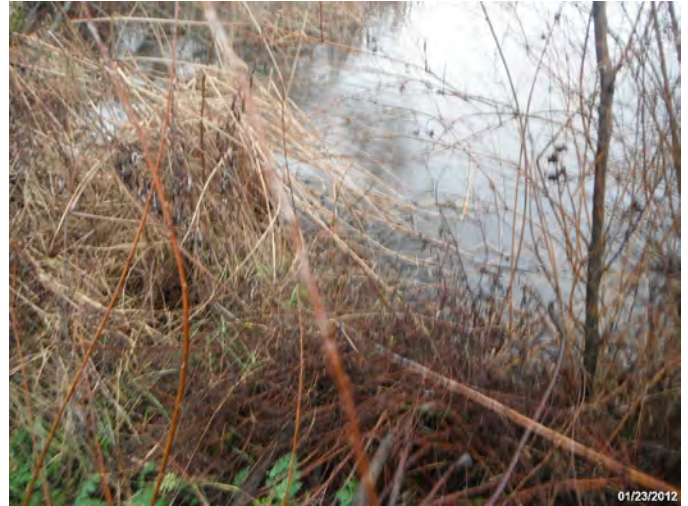
Photo: SAJO_C4_0380 Route: 403-001-0.74
Plastic WCS Drop Pipe 60ft long 24in dia. 3ft deep
Asset# NA

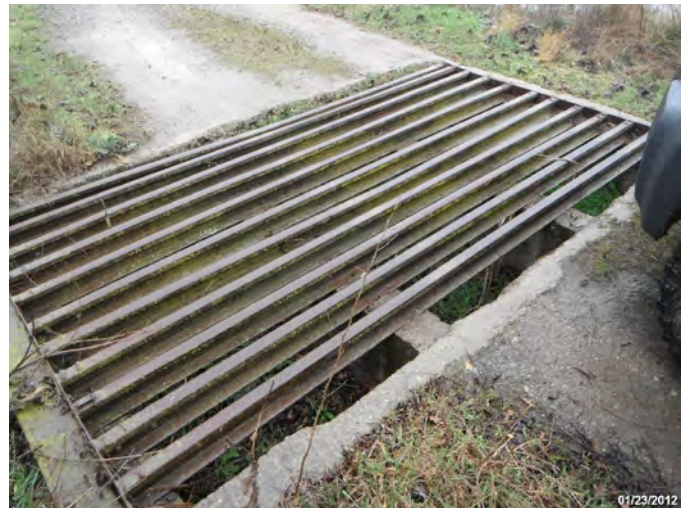
Photo: SAJO_C4_0382 Route: 404-001-0.99
Metal Cattle Guard
Asset# NA

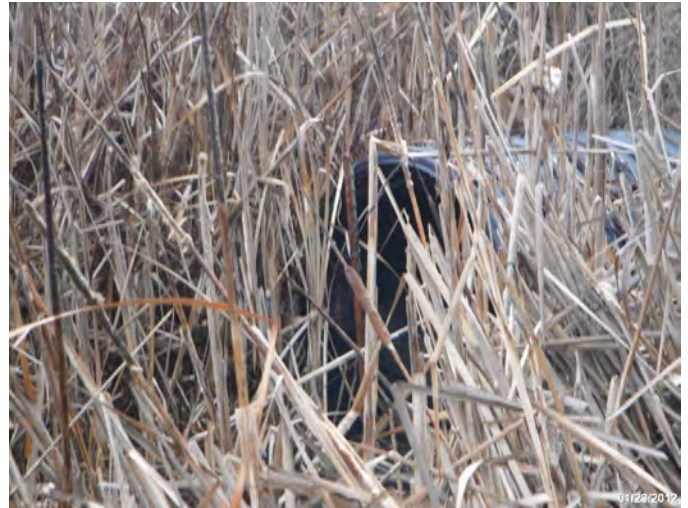
Photo: SAJO_C4_0384 Route: 405-001-0.02
Plastic Culvert 60ft long 36in dia. 2ft deep
Asset# NA

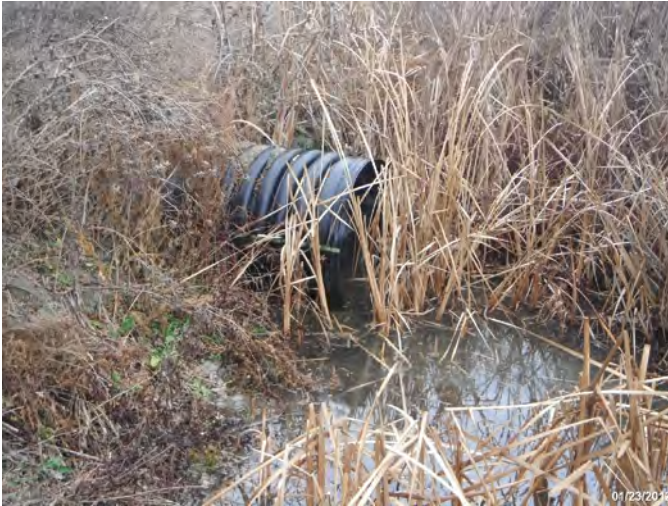
Photo: SAJO_C4_0385 Route: 405-001-0.02
Plastic Culvert 60ft long 36in dia. 2ft deep
Asset# NA

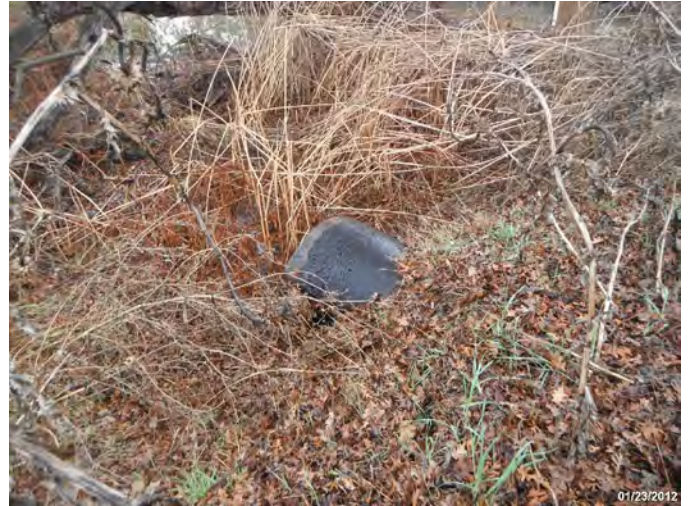
Photo: SAJO_C4_0388 Route: 405-001-0.16
Metal WCS Flashboard Riser 50ft long 36in dia. 2ft deep
Asset# NA

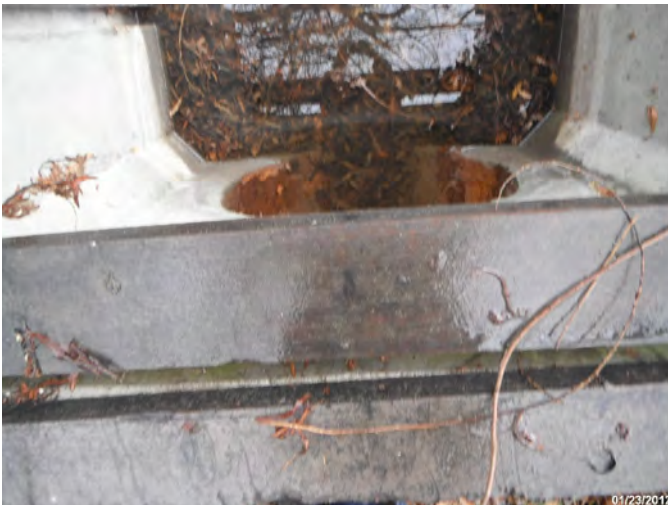
Photo: SAJO_C4_0389 Route: 405-001-0.16
Metal WCS Flashboard Riser 50ft long 36in dia. 2ft deep
Asset# NA

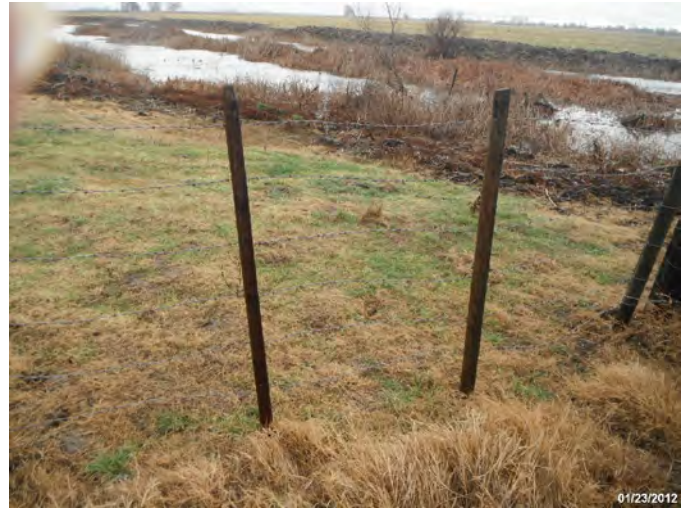
Photo: SAJO_C4_0392 Route: 405-003-0.82
Metal Gate Barbed Wire
Asset# NA

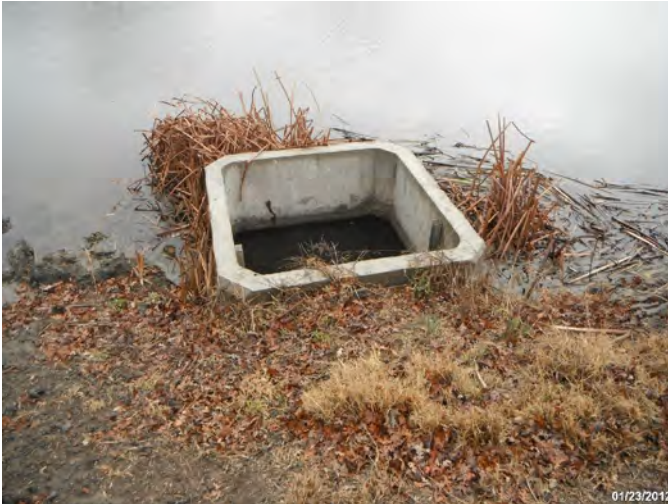
Photo: SAJO_C4_0393 Route: 405-003-1.05
Metal WCS Flashboard Riser 40ft long 48in dia. 7ft deep
Asset# NA

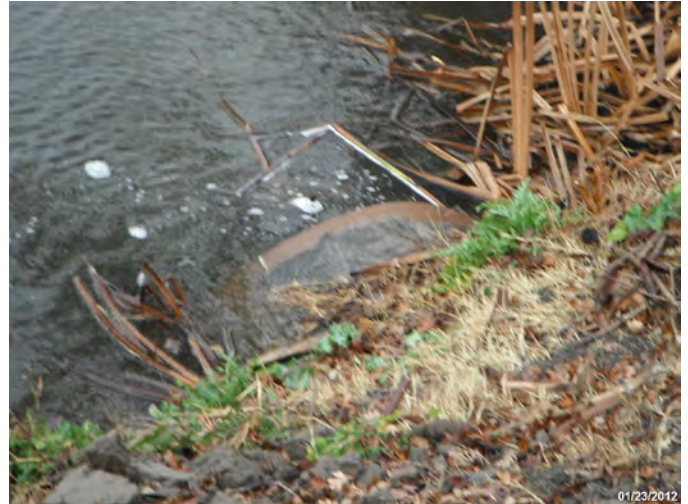
Photo: SAJO_C4_0394 Route: 405-003-1.05
Metal WCS Flashboard Riser 40ft long 48in dia. 7ft deep
Asset# NA

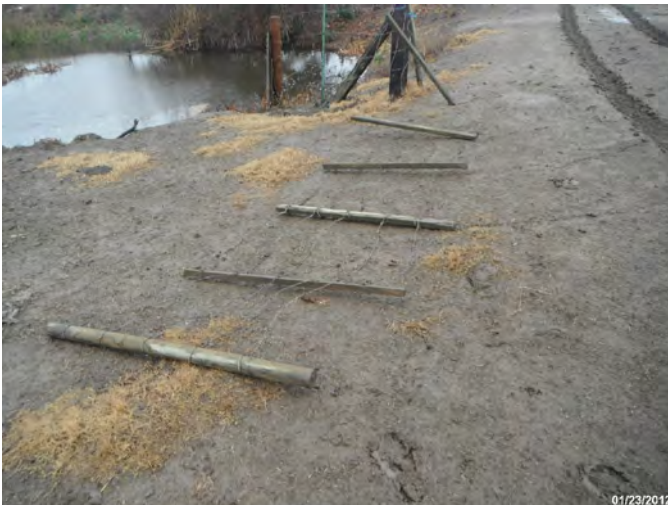
Photo: SAJO_C4_0395 Route: 405-003-1.06
Metal Gate Barbed Wire
Asset# NA

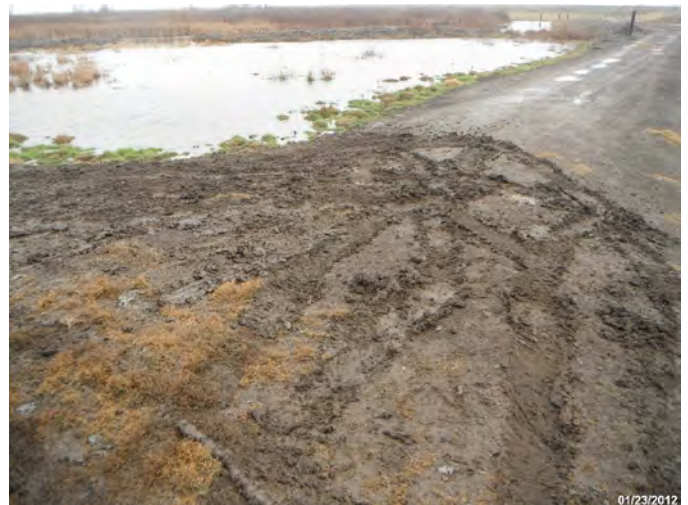
Photo: SAJO_C4_0396 Route: 405-003-1.41
Problem Area Road too muddy to drive

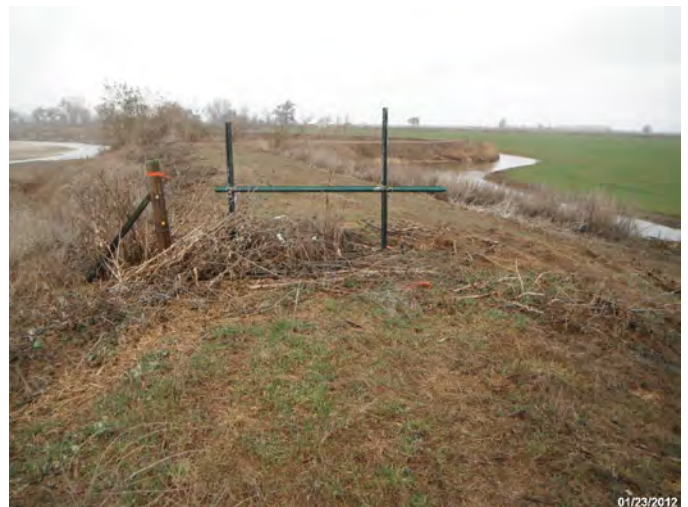
Photo: SAJO_C4_0402 Route: 406-002-1.95
Problem Area At refuge request road too muddy to drive
8-009

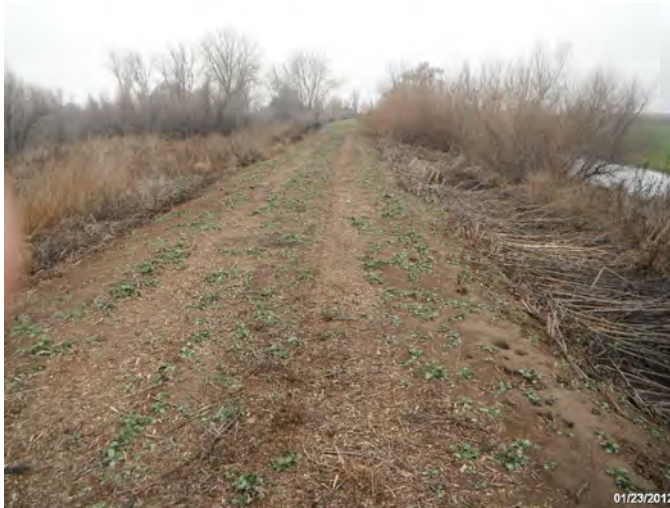
Photo: SAJO_C4_0409 Route: 406-003-1.95
Begin Section Not driven at refuge request due to soft mud

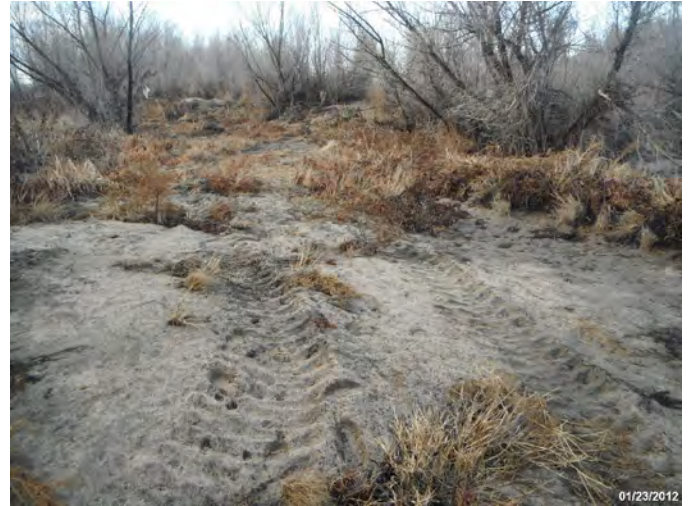
Photo: SAJO_C4_0436 Route: 409-001-0.12
Problem Area Road washed out at this point

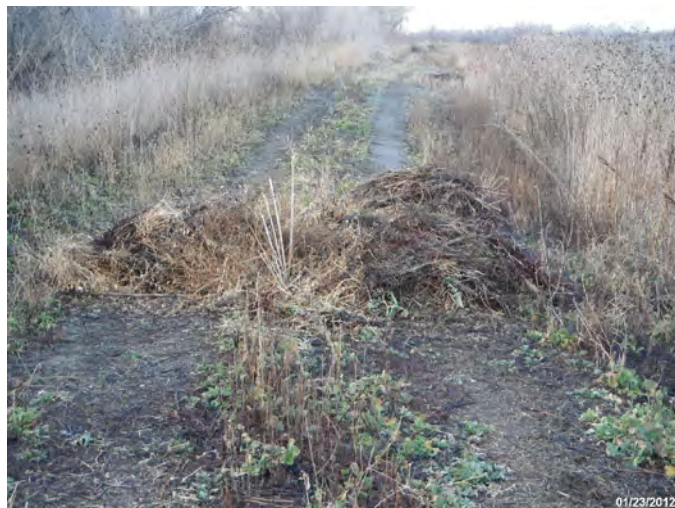
Photo: SAJO_C4_0440 Route: 409-002-0.65
Problem Area Roadblock put in by refuge staff

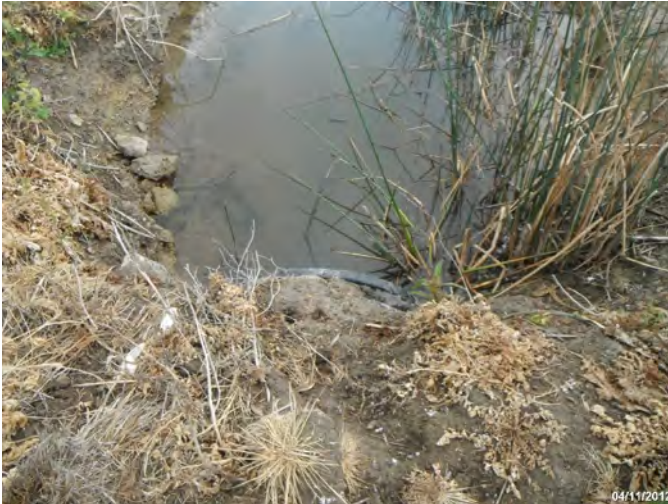
Photo: SAJO_C4_1013 Route: 437-001-0.64
Plastic Culvert 30ft long 36in dia. 2ft deep
Asset# NA

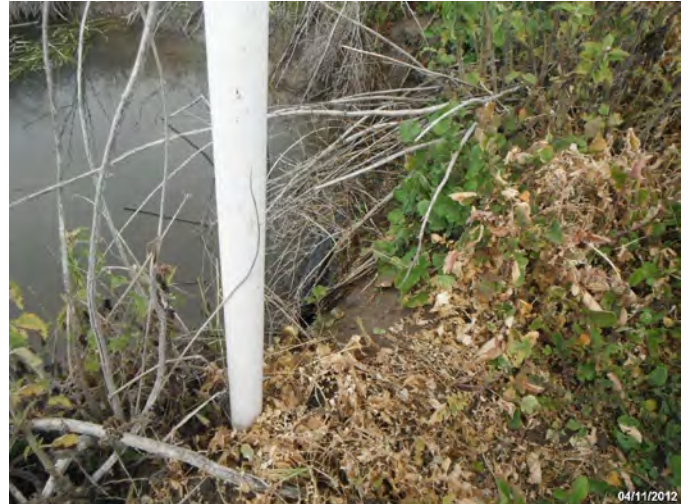
Photo: SAJO_C4_1014 Route: 437-001-0.64
Plastic Culvert 30ft long 36in dia. 2ft deep
Asset# NA

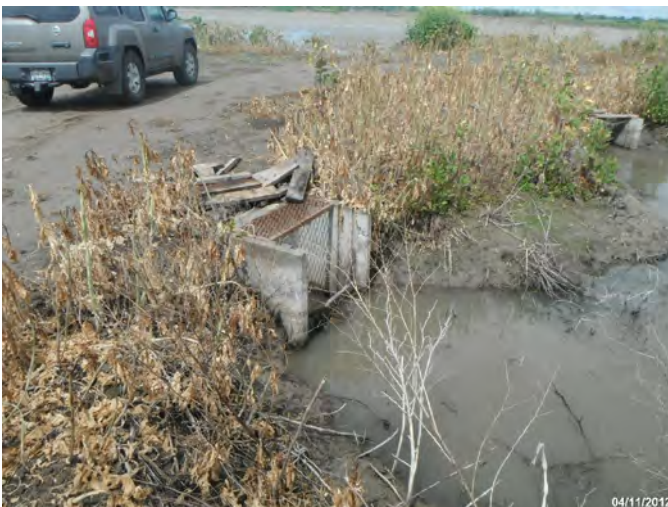
Photo: SAJO_C4_1015 Route: 437-001-0.92
Plastic WCS Flashboard Riser 30ft long 24in dia. 2ft deep
Asset# NA

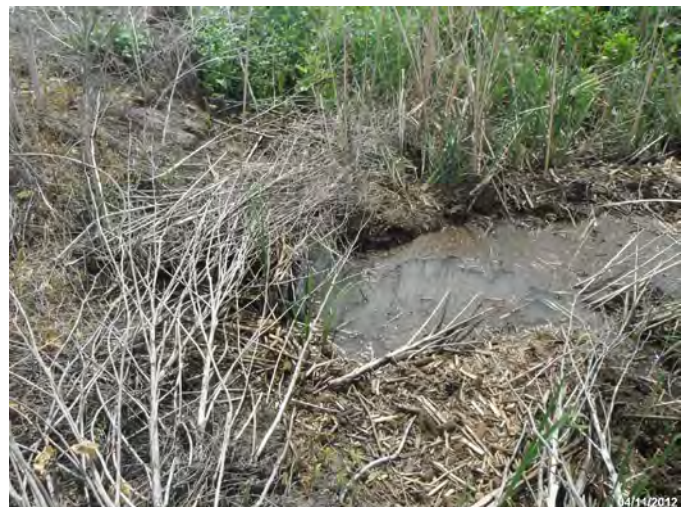
Photo: SAJO_C4_1016 Route: 437-001-0.92
Plastic WCS Flashboard Riser 30ft long 24in dia. 2ft deep
Asset# NA
8-049

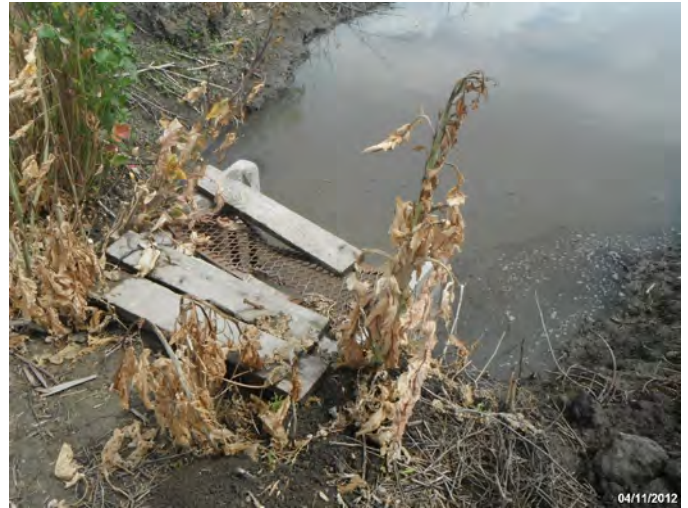
Photo: SAJO_C4_1018 Route: 438-001-0.6
Plastic WCS Flashboard Riser 30ft long 24in dia. 2ft deep
Asset# NA

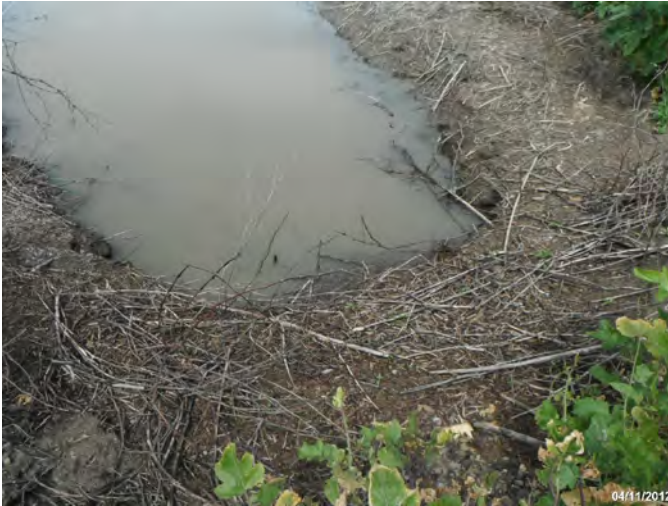
Photo: SAJO_C4_1019 Route: 438-001-0.6
Plastic WCS Flashboard Riser 30ft long 24in dia. 2ft deep
Asset# NA

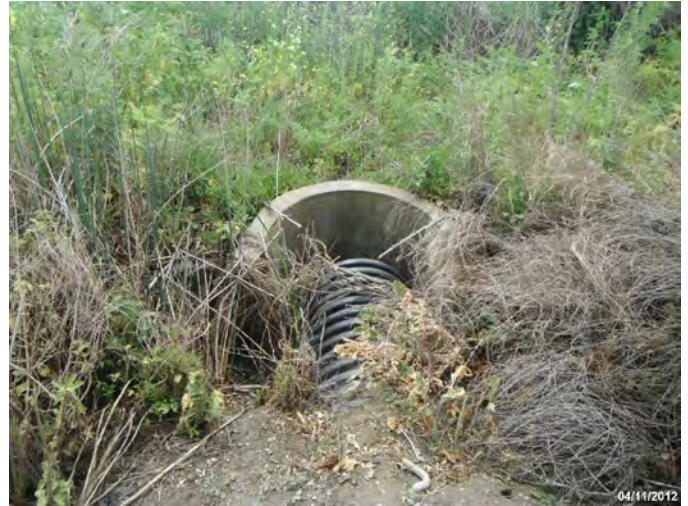
Photo: SAJO_C4_1020 Route: 438-001-0.93
Plastic WCS Flashboard Riser 25ft long 24in dia. 2ft deep
Asset# NA

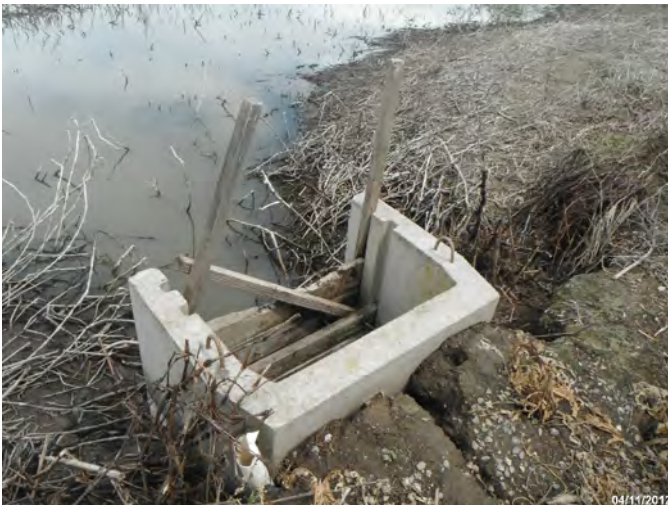
Photo: SAJO_C4_1021 Route: 438-001-0.93
Plastic WCS Flashboard Riser 25ft long 24in dia. 2ft deep
Asset# NA

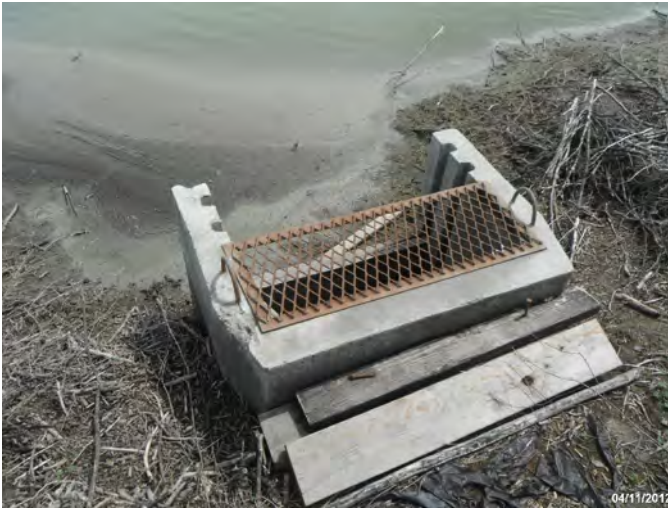
Photo: SAJO_C4_1023 Route: 438-002-1.16
Plastic WCS Flashboard Riser 25ft long 24in dia. 1ft deep
Asset# NA

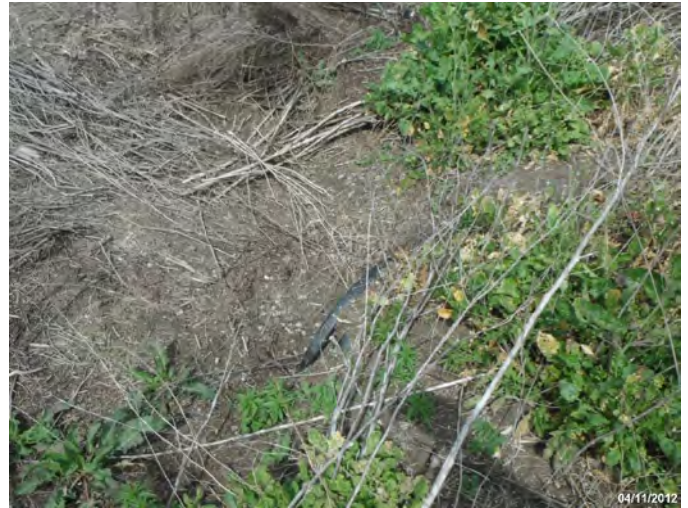
Photo: SAJO_C4_1024 Route: 438-002-1.16
Plastic WCS Flashboard Riser 25ft long 24in dia. 1ft deep
Asset# NA

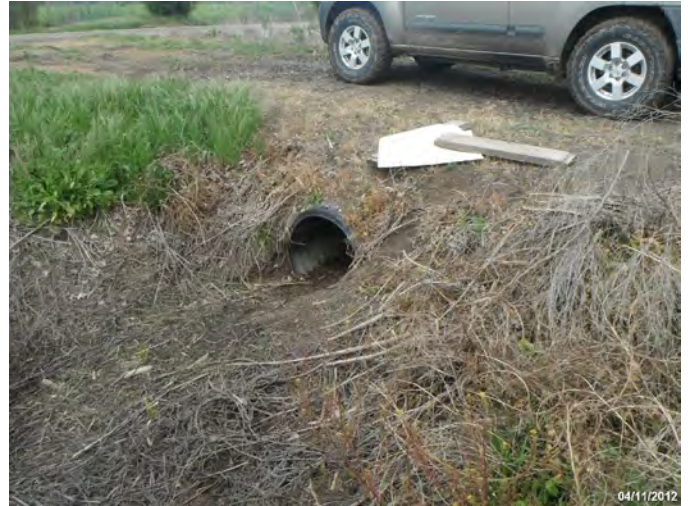
Photo: SAJO_C4_1026 Route: 438-003-1.35
Plastic WCS Flashboard Riser 30ft long 24in dia. 3ft deep
Asset# NA

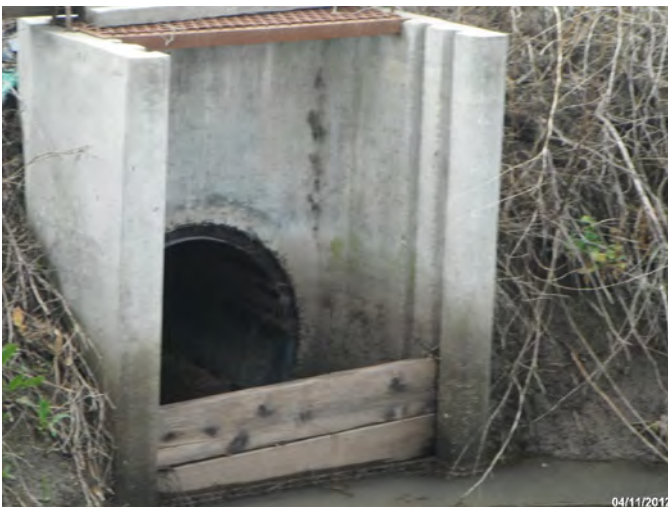
Photo: SAJO_C4_1027 Route: 438-003-1.35
Plastic WCS Flashboard Riser 30ft long 24in dia. 3ft deep
Asset# NA

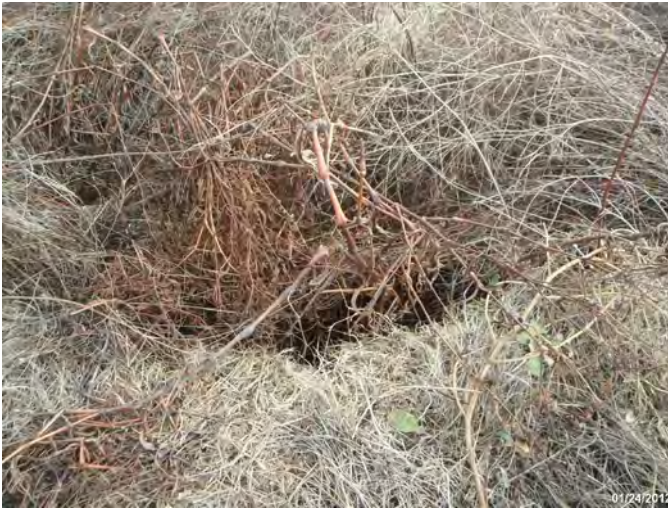
Photo: SAJO_C4_0076 Route: 600-001-0.0
Problem Area Location of Field 6 Drain Road.
Road entrance caved in and washed out. Unable to drive

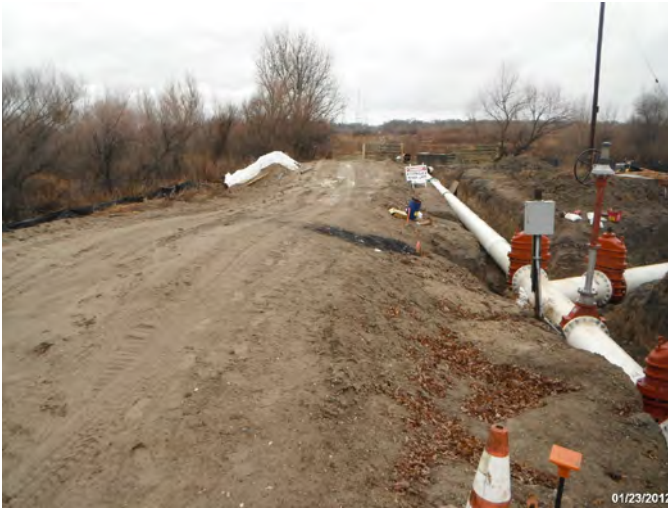
Photo: SAJO_C4_0414 Route: 601-001-0.0
Problem Area Entrance to Vierra Unit North Access Road.
Asset number 10048314. Unable to access due to construction

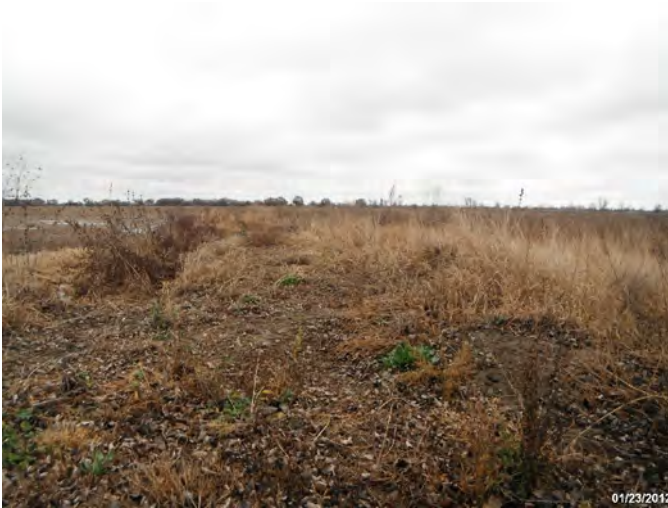
Photo: SAJO_C4_0407 Route: 602-001-0.0
Problem Area Location of Colwell and Christman Unit
South Access Road. Road too indistinct and overgrown to drive.
Asset Number 10048310
